Manhole Inspection Summary

Manhole # S110O1014MH

Location Address: **3000 OAKLEY AVE**

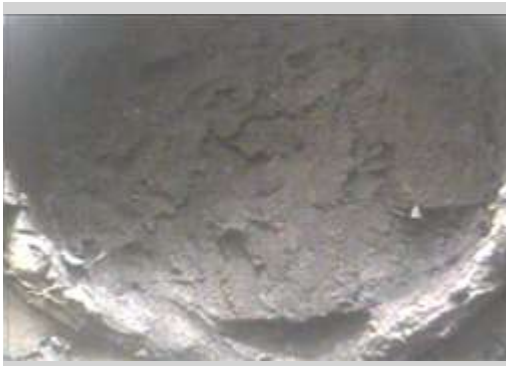
I9 BOTTOM

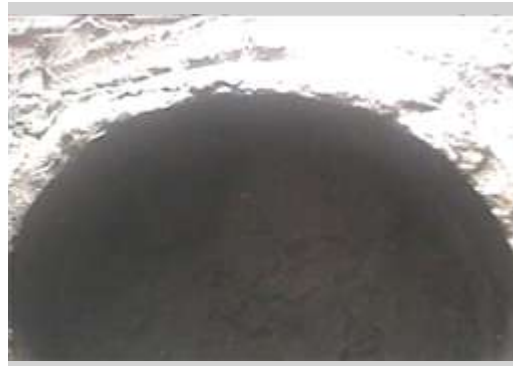
TOP OF ABANDONED I9

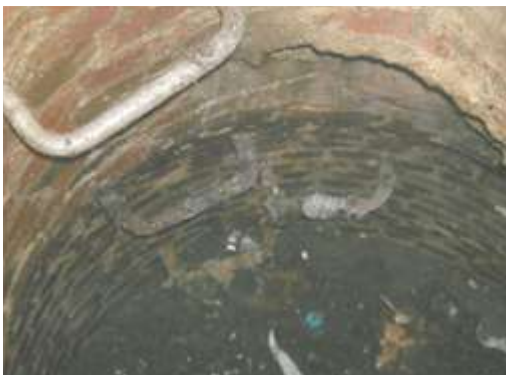
Defect 2

SURCHARGE EVIDENCE ON STEPS

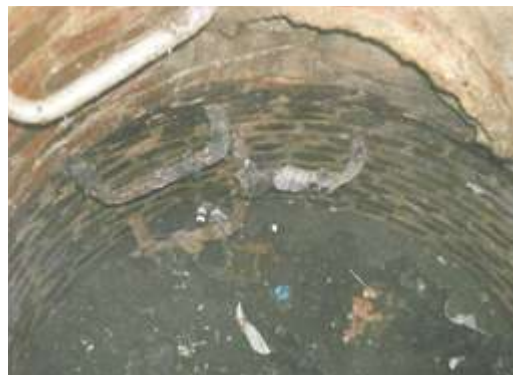
Defect 1

Steps Count: **5** Missing: **0** ☒ **Corroded**

CORRODED STEPS

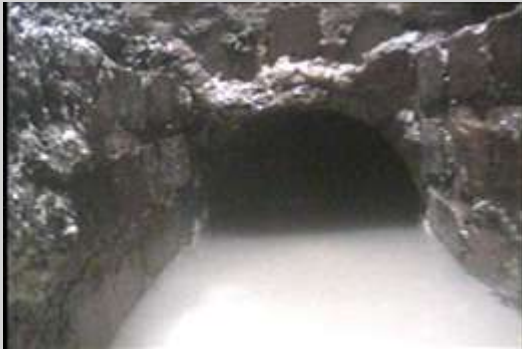
12 O'Clock Outflow

8 in. Circular Gravity Sewer
Pipe Out @ 12 O'Clock

Pipe Height: **8.4** (in.) Rod and Bar (Angled)
Pipe Material: **Clay** ☐ Pipe Lined
Invert Depth: **10.91** (ft.) Flow Characteristics: **Slow**
Deposits: ☒ None ☐ Mud ☐ Sludge ☐ Debris ☐ Grease
Silt Depth: (in.) Deposits Extent:
Infiltration: **None** Pipe Seal Cond: **Sound**

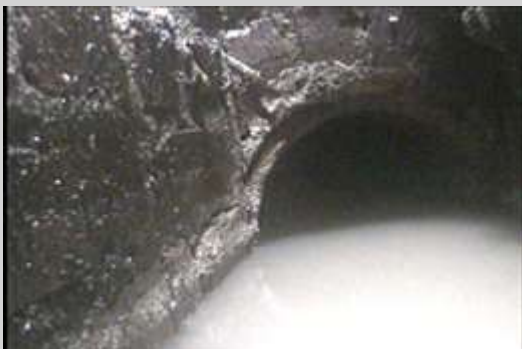
5 O'Clock Inflow

8 in. Circular Gravity Sewer
Pipe In @ 5 O'Clock

Pipe Height: **8.4** (in.) Rod and Bar (Angled)
Pipe Material: **Clay** ☐ Pipe Lined
Invert Depth: **10.84** (ft.) Flow Characteristics: **Slow**
Deposits: ☒ None ☐ Mud ☐ Sludge ☐ Debris ☐ Grease
Silt Depth: (in.) Deposits Extent:
Infiltration: **None** Pipe Seal Cond: **Sound**
